Manhole Inspection Summary

Manhole # S25E__045MH

Insp Date: **8/7/07 8:41 AM**

Location Address: **1215 SARATOGA ST**

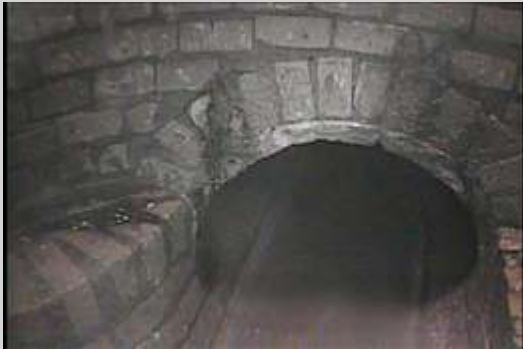
12 O'Clock Outflow

21 in. Circular Gravity Sewer
Pipe Out @ 12 O'Clock

Pipe Height: **19.2** (in.) Rod and Bar (Angled)
Pipe Material: **Clay** ☐ Pipe Lined
Invert Depth: **13.80** (ft.) Flow Characteristics: **Fast**
Deposits: ☒ None ☐ Mud ☐ Gravy ☐ Debris ☐ Grease
Silt Depth: (in.) Deposits Extent:
Infiltration: **None** Pipe Seal Cond: **Sound**

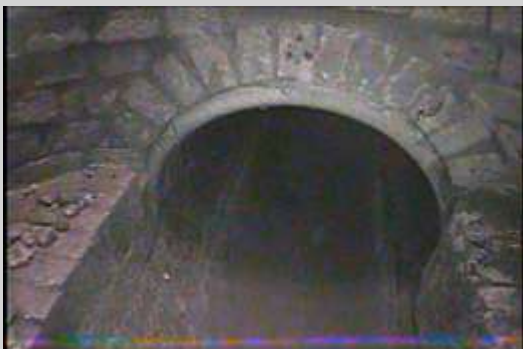
6 O'Clock Inflow

21 in. Circular Gravity Sewer
Pipe In @ 6 O'Clock

Pipe Height: **20.4** (in.) Rod and Bar (Angled)
Pipe Material: **Clay** ☐ Pipe Lined
Invert Depth: **13.75** (ft.) Flow Characteristics: **Fast**
Deposits: ☒ None ☐ Mud ☐ Gravy ☐ Debris ☐ Grease
Silt Depth: (in.) Deposits Extent:
Infiltration: **None** Pipe Seal Cond: **Sound**
